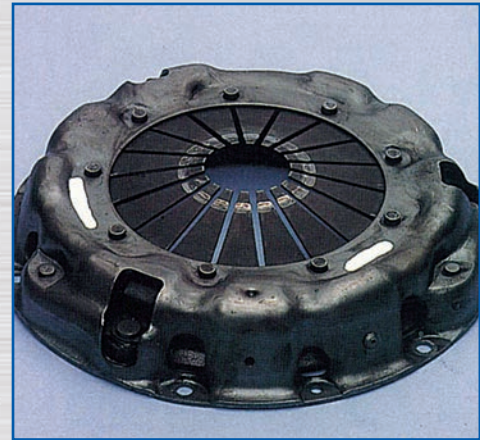
PROBLEM: Excessively worn diaphragm fingers

SYMPTOM: Pedal graunch sometimes described as erratic feeling when depressing clutch pedal with engine running but OK when not running/ Notchy clutch pedal

CAUSE:

1. Eccentricity between the axis of rotation of the clutch cover pressure plate assembly and that of the clutch thrust bearing
2. Inferior clutch thrust bearing (not self centering type)
3. Worn release bearing sleeve carrier or clutch fork
4. Lack of free travel

1. Refer misalignment tips on page 78
2. Fit proper self centering bearing
3. Rectify release mechanism and align
4. Adjust free travel to manufacturer's specification

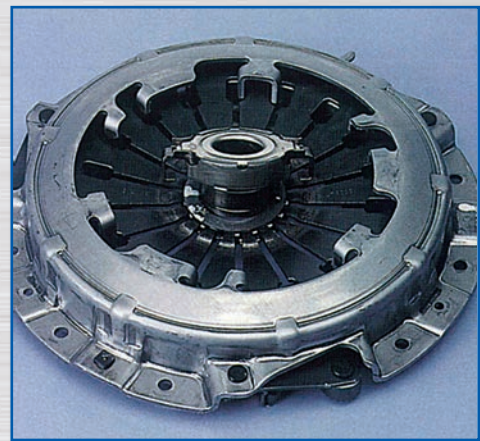
PROBLEM: Bearing retainer clip not connected to diaphragm

SYMPTOM: No pressure on clutch pedal - new pull type clutch just installed

CAUSE: Proper installation procedures have not been followed. The snap-in mechanism of the release bearing has not been clipped on firmly

SOLUTION: When the transmission is installed onto the mating area of the engine the release bearing is preliminarily set into position where the release fork of the transmission is fitted

After installation of the transmission, the release lever must be pulled in the reverse direction to secure the release bearing to the retaining mechanism. The bearing is then snapped in. (Also refer to manufacturer's specifications)

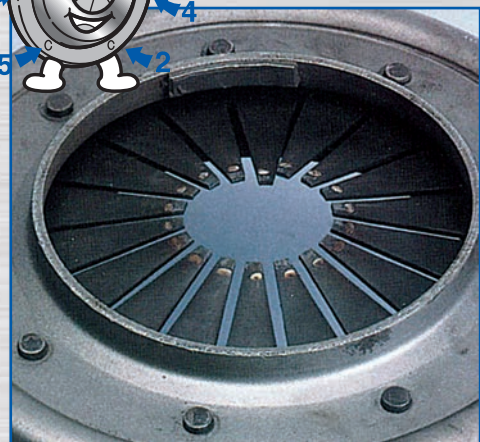
PROBLEM: Clutch diaphragm fingers or levers are uneven

SYMPTOM: Clutch drag/Pedal vibration

1. The pressure plate cover assembly was torqued down incorrectly i.e. not diagonally
2. The pressure plate cover assembly was torqued down with an air wrench

1. Refer to page 19 for proper tightening specifications.
2. Never use air tools to torque down a clutch

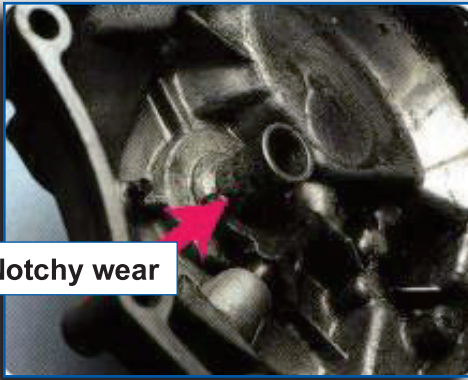
Notchy wear on front cover

- PROBLEM:** Abnormal wear on the release bearing guide tube
- SYMPTOM:** Sticky or notchy pedal/Slipping clutch
- CAUSE:** Driveline misalignment. No grease applied to guide tube
- SOLUTION:** Refer misalignment tips on page 78. Apply appropriate grease. Renew worn parts

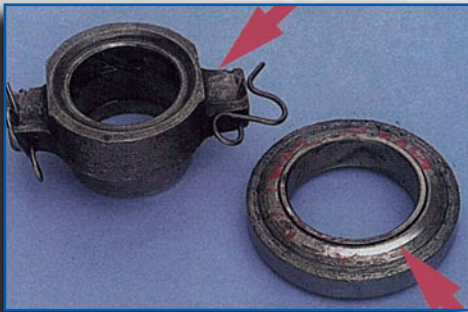
- PROBLEM:** Worn clutch thrust bearing carrier
- SYMPTOM:** Pulsating pedal with engine running
- CAUSE:** Faulty installation as the clutch thrust bearing carrier is worn on the saddle where the fork pivots. This also reduces the tension on the wear clip retainer. In this case, due to the lack of tension, the fork has become dislodged and scored the back of the bearing
- SOLUTION:** Always replace worn clutch thrust bearings, carriers and worn forks
